Interreg IIB Alpine Space  
ALPTER Project  
'Terraced landscapes  
of the alpine arc'

# Terracing: a barrier against land degradation

ALPTER PROJECT NEWSLETTER - ISSUE N. 4

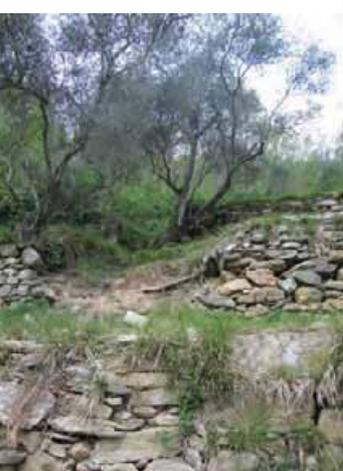
The figures beside show the preliminary results obtained from the survey on a surface area covering 90 % of the Bisagno basin. The quick survey has allowed collecting data from more than 300 terraced slopes, which have been analysed in a GIS environment together with the lithology and the main morphometric features. The diagrams show that the disorder evidences in terraces are primarily concentrated in the slopes facing south and north and with a high slope gradient. Lithology doesn't seem to affect particularly the disorder. At the same time, the graphs put in evidence how disordering is almost equally present in abandoned and in cultivated terraces, while the more frequent evidences are present in little slopes rather than in large ones.

The gathered data allows to perform a preliminary basic statistical analysis that gets some early results. The lithology of the substratum, which is partly responsible for the drainage, seems not to significantly influence the stability of terraces. This result, which may look in contrast with the erosion models, may be interpreted with a stronger effect on stability caused by others parameters. At the current stage of the analysis these may be identified mainly in the slope gradient and aspect; the first is related to the intensity of erosive processes and the second to weathering, which in the studied area is influenced by strong rainfalls, often related to southern wind. The high number of disorders in terraced structures facing north may be related to the tendency of retaining moisture.
