**Project Alpter**  
***“Terraced landscapes of the alpine arc”***  
Eu Programme Interreg IIIB Alpine Space

***Methodological cues for the analysis of the terraced  
slope in the pilot area***  
***Pianazzola-Bregaglia – Data Sheet Analysis 1:5000***

**Alice G. Dal Borgo - Human Geography Institute, State University of Milan**  
**Tecla Pagnoncelli - Earth Science Department, State University of Milan**

**Trans-national Meeting**  
12-13 October 2006  
Goriska Brda (SLO)

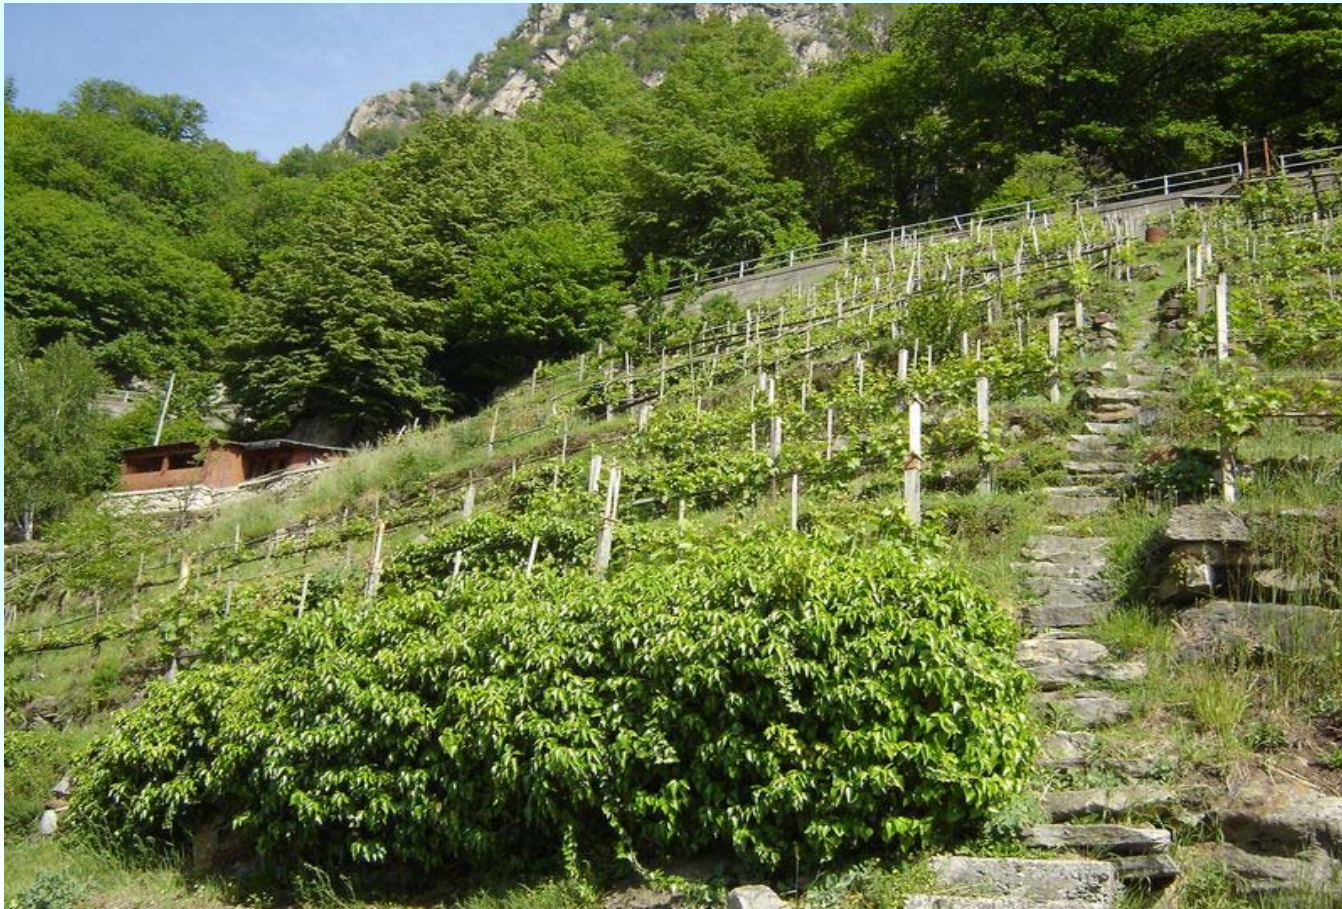
Data sheet 1:5000 example:

*“Cultivated thalweg”*

Pilot area:	(2) IMPLUVIO COLTIVATO	Cartography with perimeter of terracements. Attachment (A): Position Map 
Terraced surface (Km²):	0.005	
Min altitude:	530 m s.l.m.	
Max altitude:	550 m s.l.m.	
Average slope:	60% 31°	
Notes:	The Data sheet analyses active vineyards, located closed to an seasonal drainage line and between the hairpins.

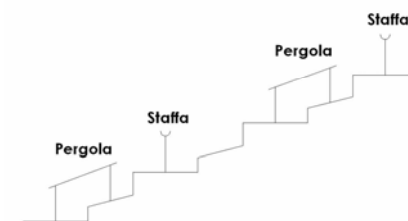
Image 3: transect of vineyard terraces.

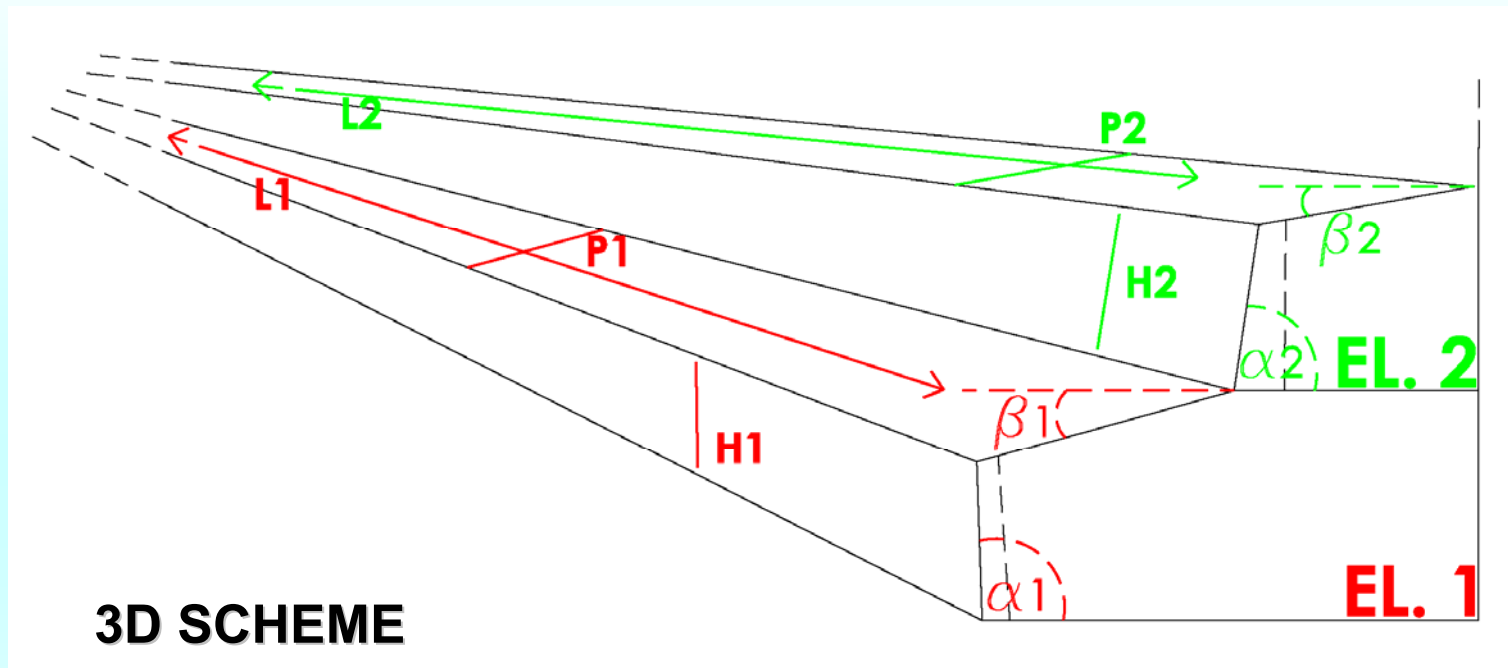
**L = LENGTH OF THE STRIPE**

**$\beta$  = SLOPE OF THE STRIPE**

**H = HEIGHT OF THE WALL**

**$\alpha$  = SLOPE OF THE WALL\***

**P = WIDTH OF THE STRIPE**

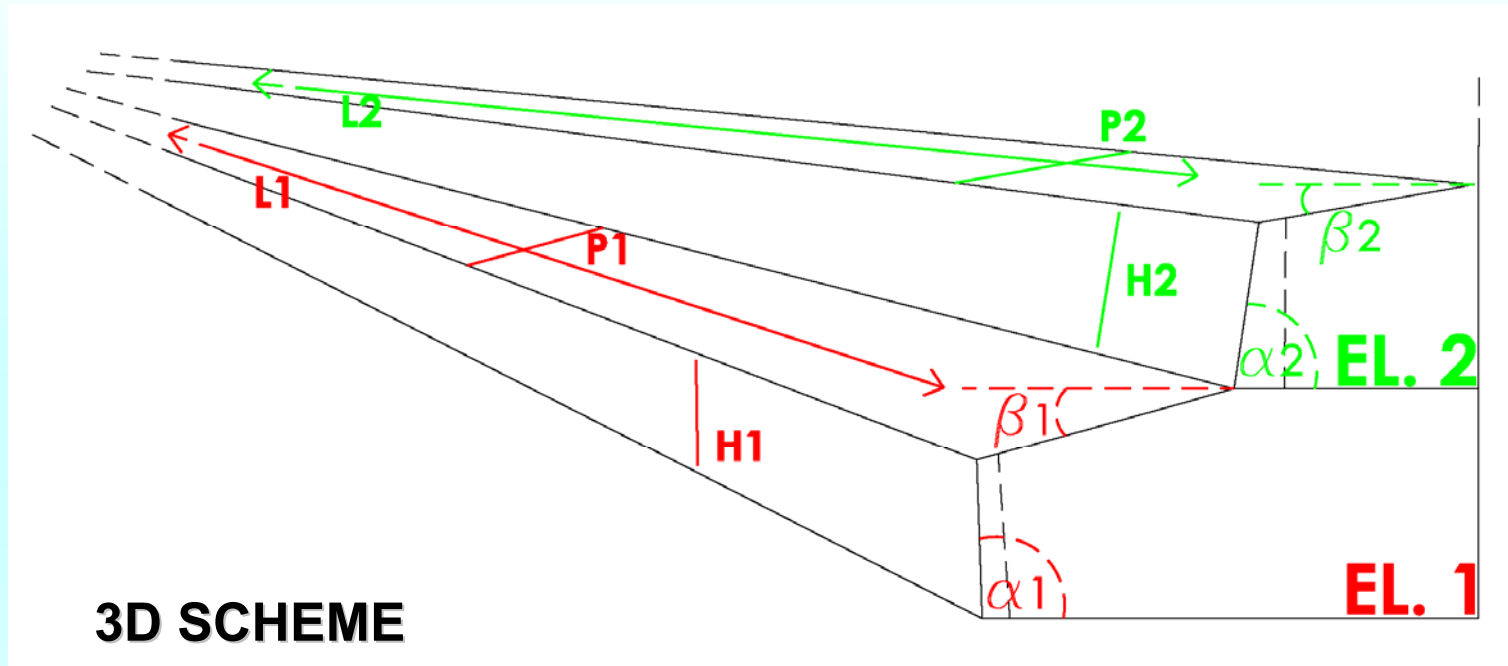
**a = SLOPE OF THE WALL\***

- Paragraph B - We introduced a value in degrees that varies from...
- an hypothetical  $0^\circ$  (the wall is completely stretched towards the mountain)
  - passing through  $90^\circ$  (the wall is perfectly vertical)
  - to another hypothetical  $180^\circ$  (the wall is completely collapsed towards the valley).

We introduced a value in degrees that varies from hypothetical 0° (the wall is completely stretched towards the mountain) passing through 90° (the wall is perfectly vertical) to another hypothetical 180° (the wall is completely collapsed towards the valley).

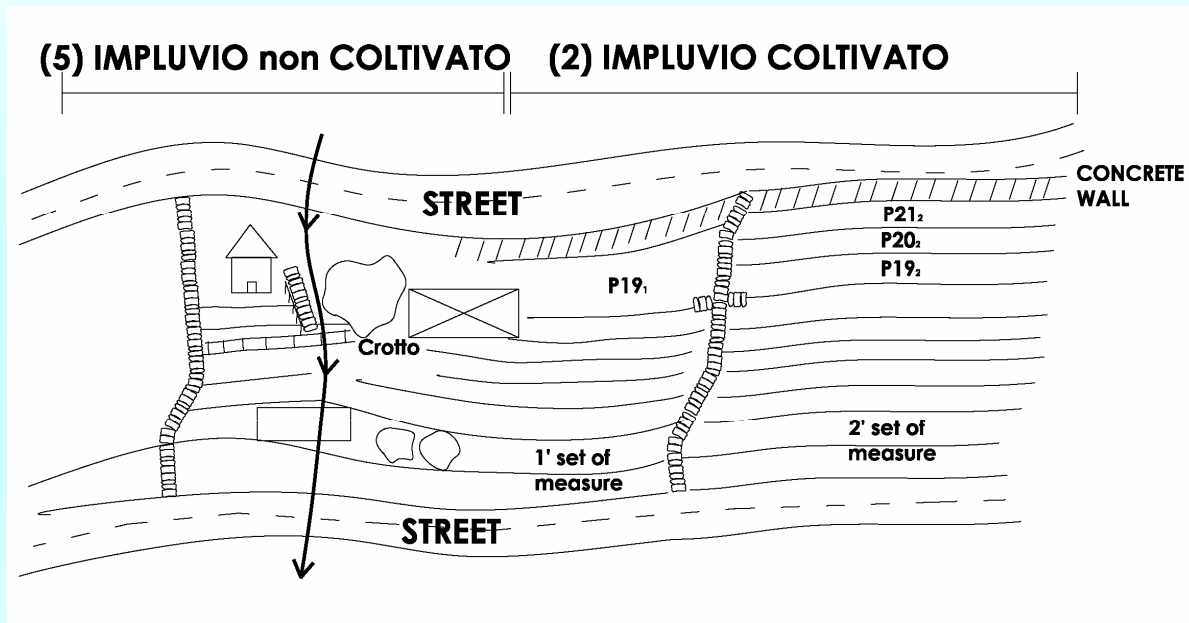
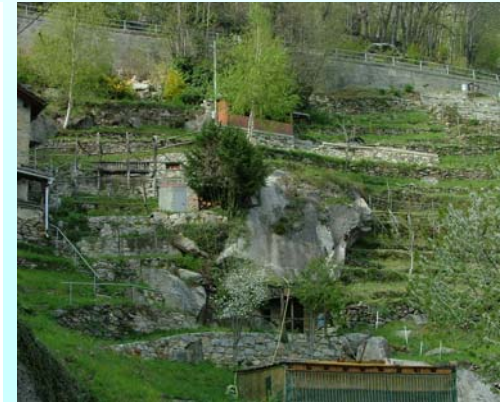
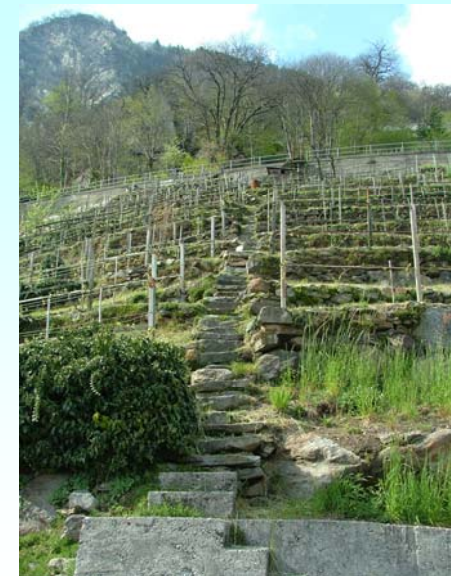
H = HEIGHT OF THE WALL

### 1' SET OF MEASURES

AVERAGE VALUE = 0,82

MINIMUM VALUE = 0,4

MAXIMUM VALUE = 4,0

MODAL VALUE = 1,2

STANDARD DEVIATION = 1,03

### 2' SET OF MEASURES

AVERAGE VALUE = 1,23

MAXIMUM VALUE = 2,4

MODAL VALUE = 1,5

STANDARD DEVIATION = 0,59

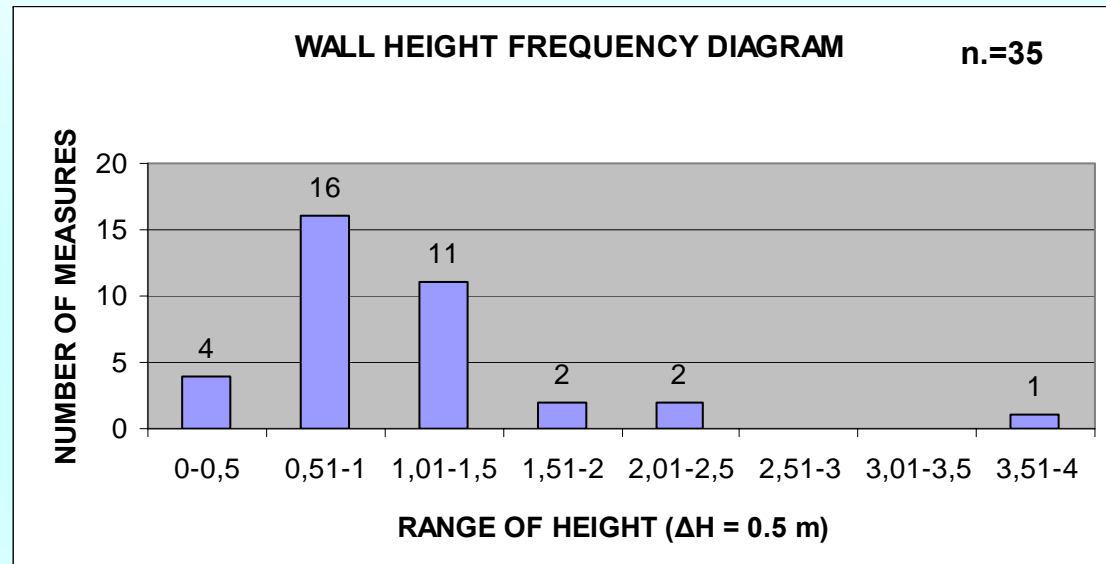
H = HEIGHT OF THE WALL

**AVERAGE VALUE = 1,62**

**MINIMUM VALUE = 0,4**

**MAXIMUM VALUE = 4,0**

**MODAL VALUE = 1,0**

**STANDARD DEVIATION = 0,82**

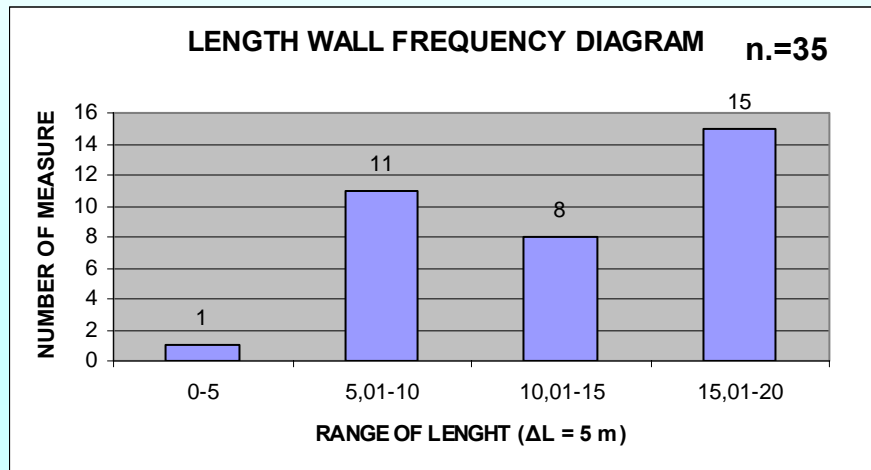
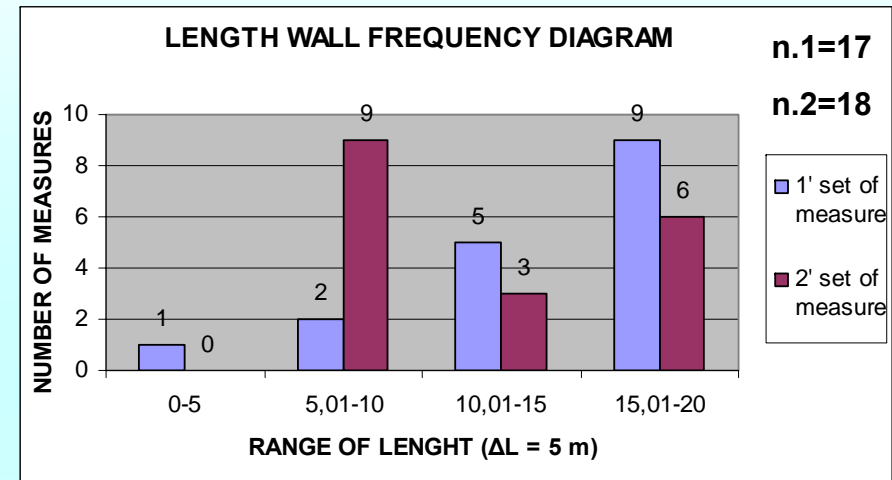
L = LENGHT OF THE STRIP

**AVERAGE VALUE = 14,08**

**MINIMUM VALUE = 4,7**

**MAXIMUM VALUE = 20**

**MODAL VALUE = 10**

**STANDARD DEVIATION = 4,39**

**1' SET OF MEASURES**

**AVERAGE VALUE = 14,72**

**2' SET OF MEASURES**

**AVERAGE VALUE = 12,29**

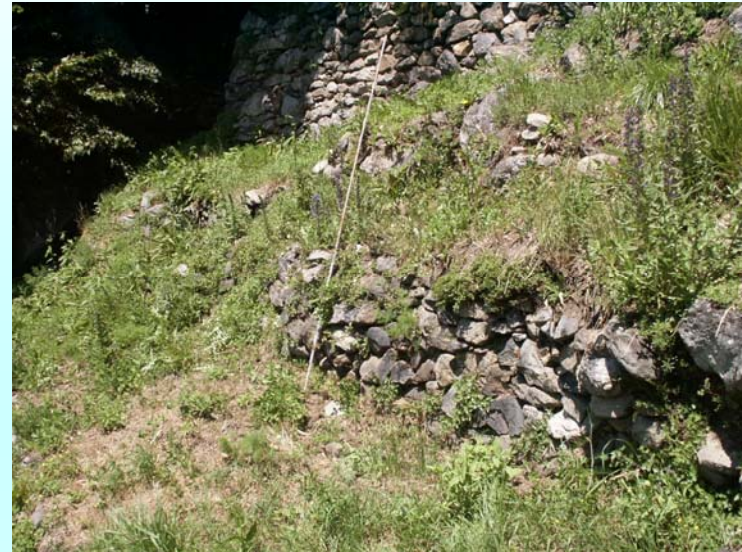
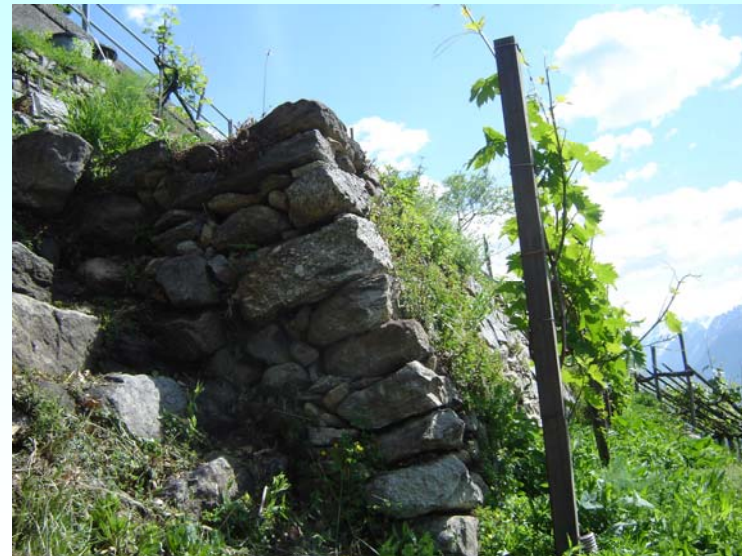
$\alpha$  = SLOPE OF THE WALL

Range of slope (angle°)

$$\Delta\alpha = 5^\circ$$

$\alpha > 90^\circ$      $\longrightarrow$     downslope

$\alpha < 90^\circ$      $\longrightarrow$     upslope

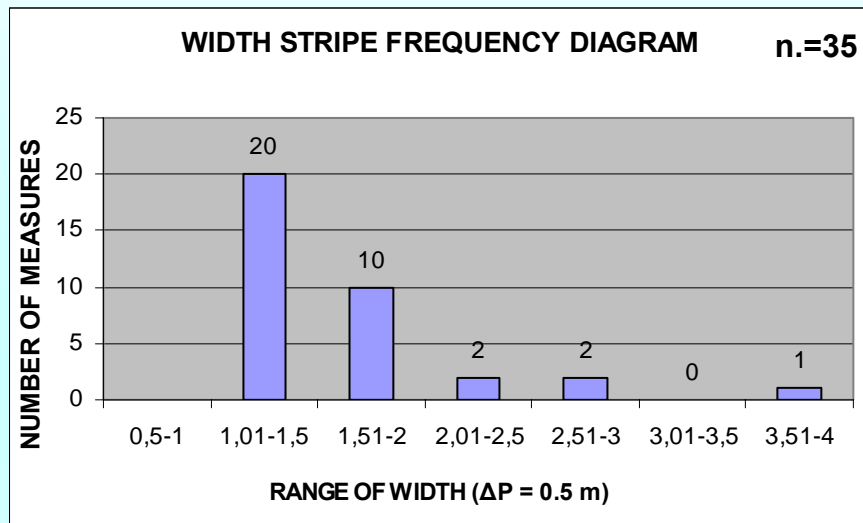
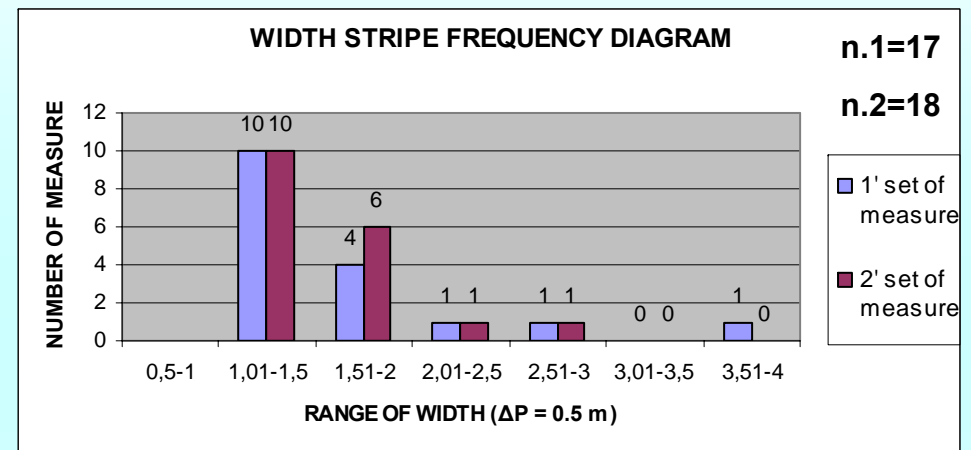
P = WIDTH OF THE STRIPE

**AVERAGE VALUE = 1,67**

**MINIMUM VALUE = 1**

**MAXIMUM VALUE = 4**

**MODAL VALUE = 1,50**

**STANDARD DEVIATION = 0,67**

**1' SET OF MEASURES**

**AVERAGE VALUE = 1,63**

**2' SET OF MEASURES**

**AVERAGE VALUE = 1,61**

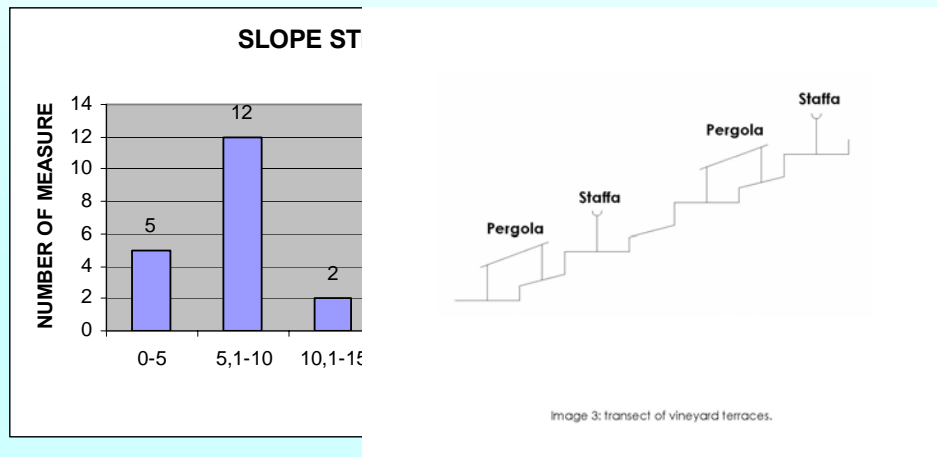
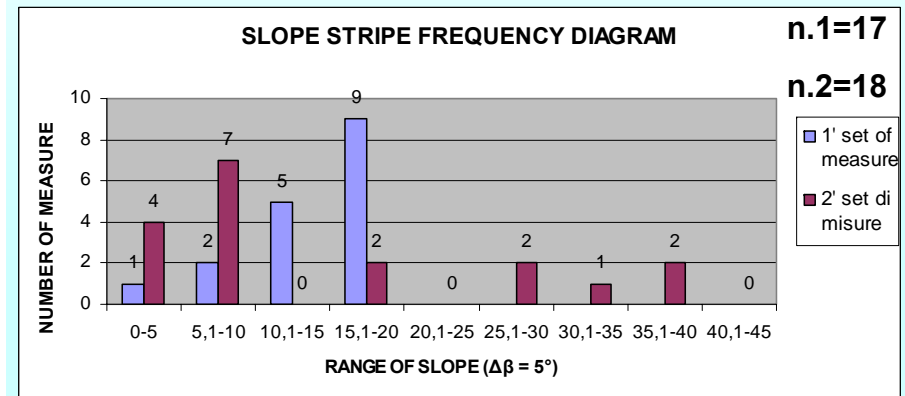
$\beta$  = SLOPE OF THE STRIPE

**AVERAGE VALUE = 17,94**

**MINIMUM VALUE = 5**

**MAXIMUM VALUE = 45**

**MODAL VALUE = 10**

**STANDARD DEVIATION = 12,38**

**1' SET OF MEASURES**

**AVERAGE VALUE = 19,58**

**2' SET OF MEASURES**

**AVERAGE VALUE = 15,83**

We introduced a value in degrees that varies from 0° (the stripe is perfectly horizontal) to 90° (hypothetical completely vertical stripe).

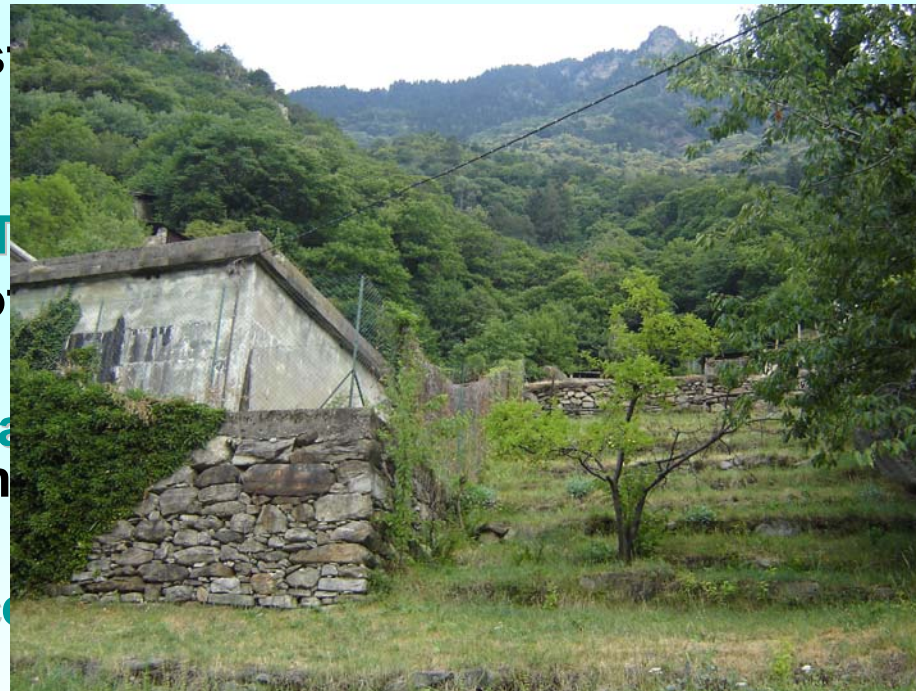
**•FIELD TESTS**

by permeability test (double ring infiltrometer)

double ring
