Natural hazards in terraced landscapes

G. Brancucci and G. Paliaga

POLIS Department University of Genova - Italy

ALPTER: Terraced landscapes of the alpine arc

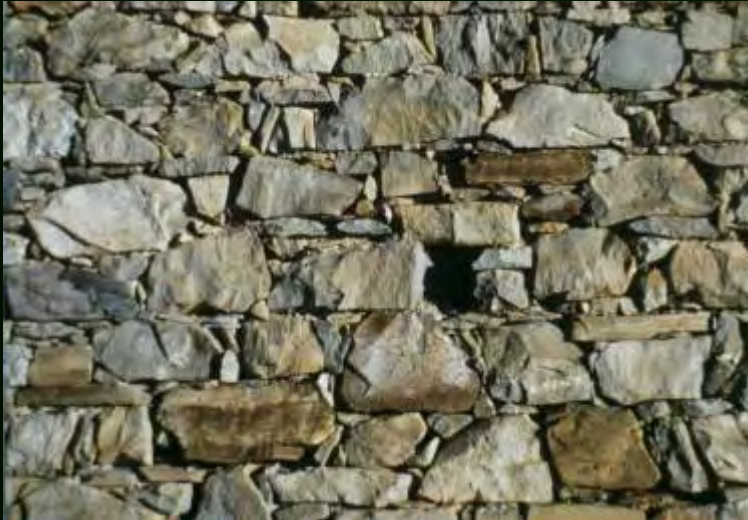
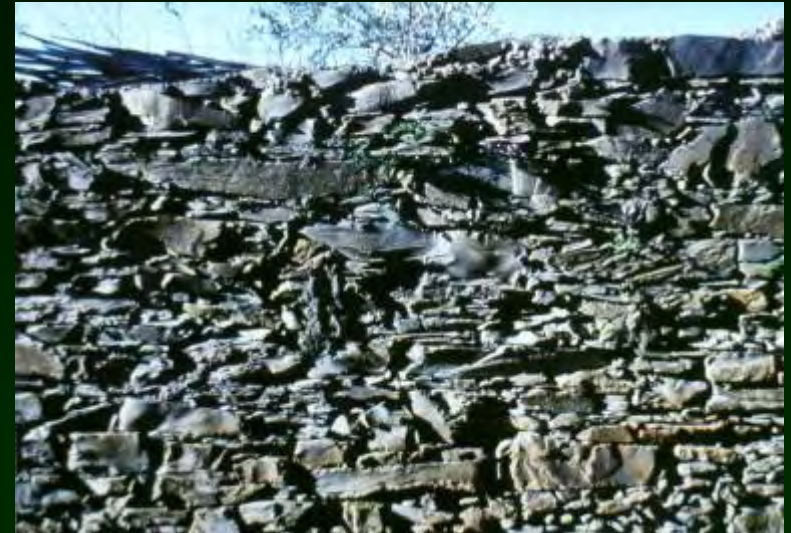
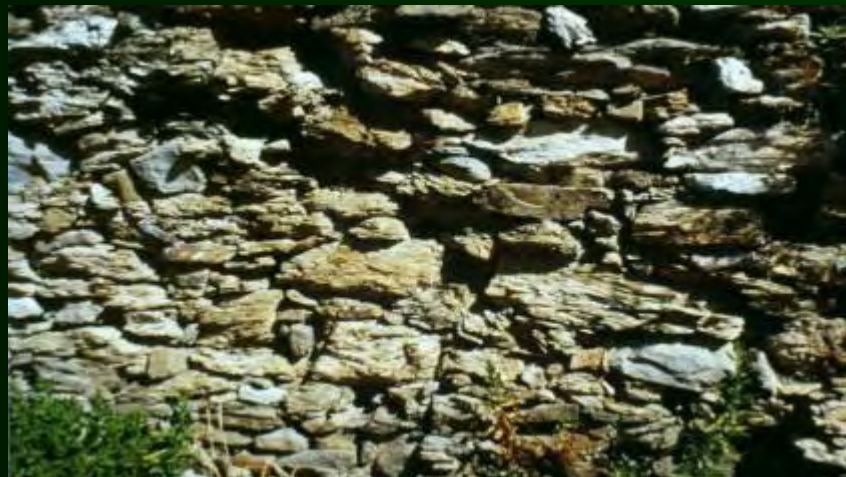
Lithology and stones dispositions

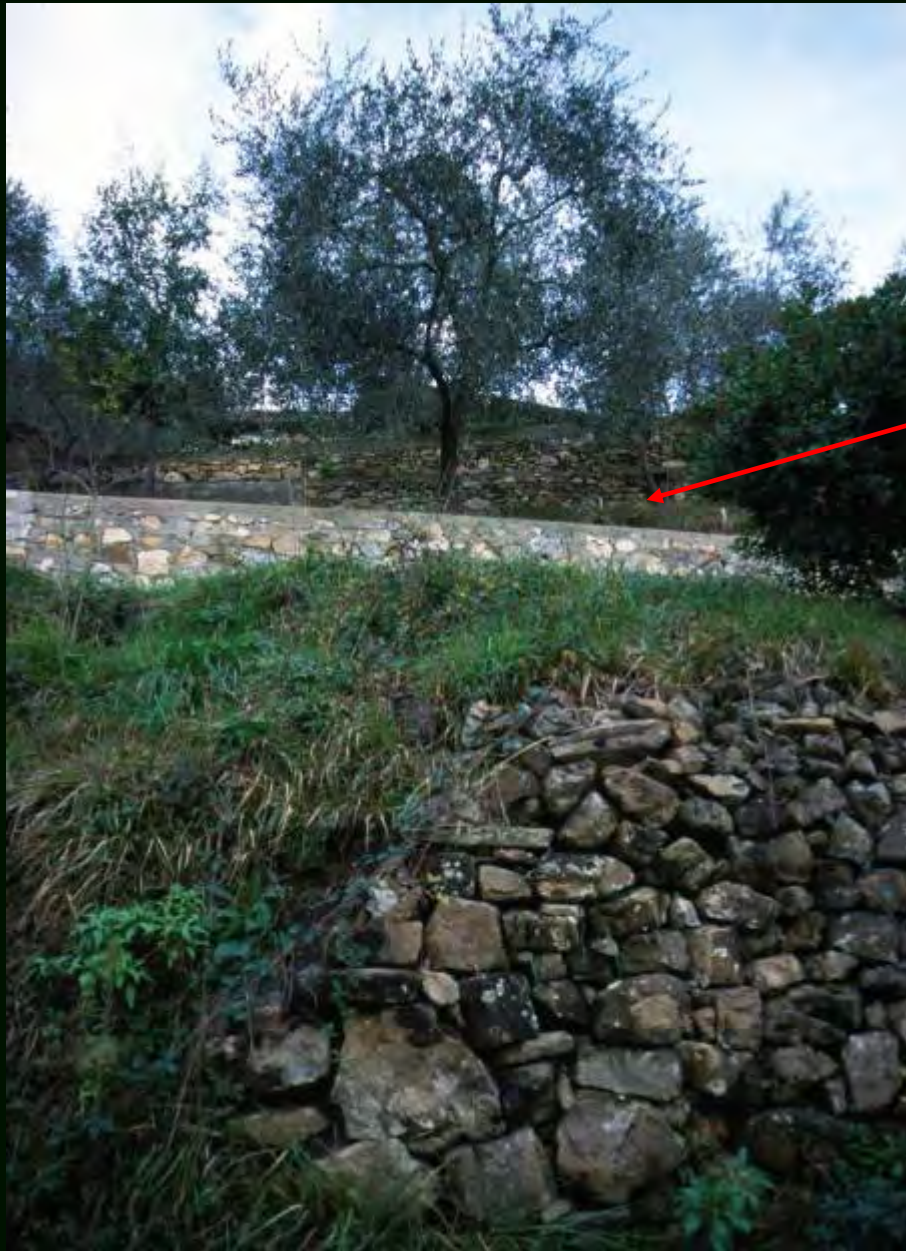
Wrong recovery

The permeability of
the original wall
has not been
conserved

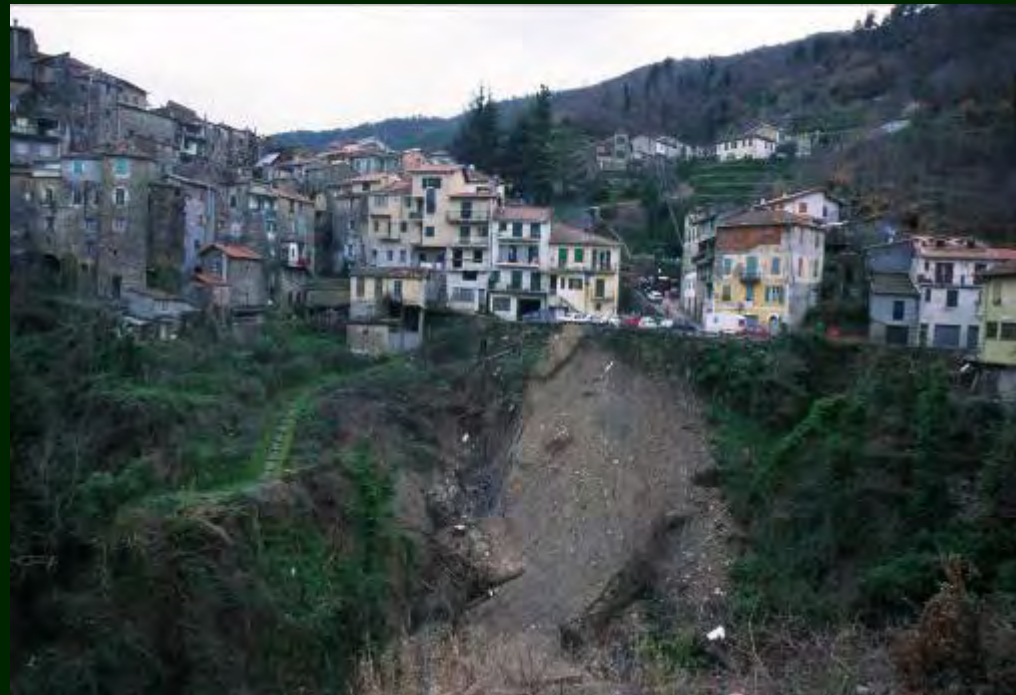
Consequences of the lack and mistakes in managing a modified territory:

The effect in case of severe rainfall:
Landslides and heavy solid transport in the stream.

The stronger effects reach the lower part of the basin.

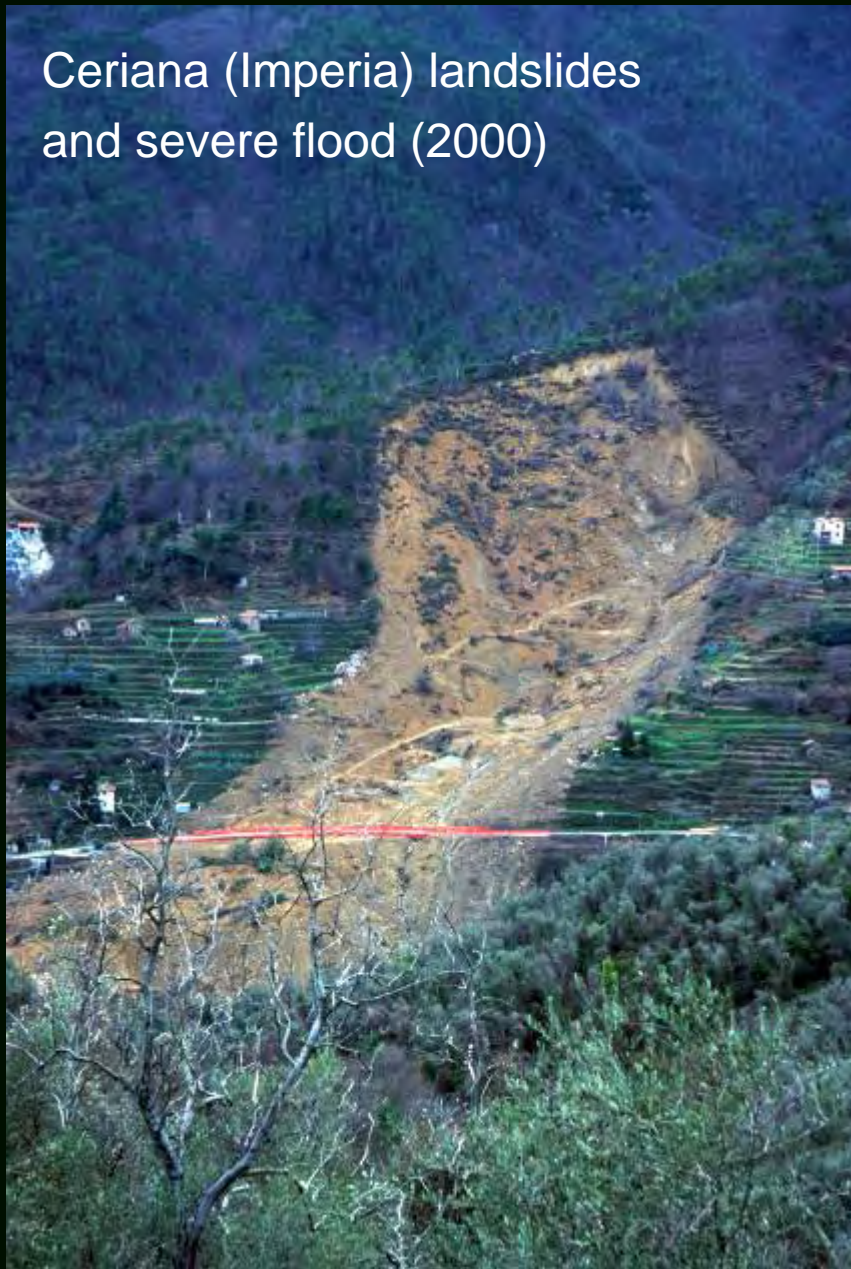
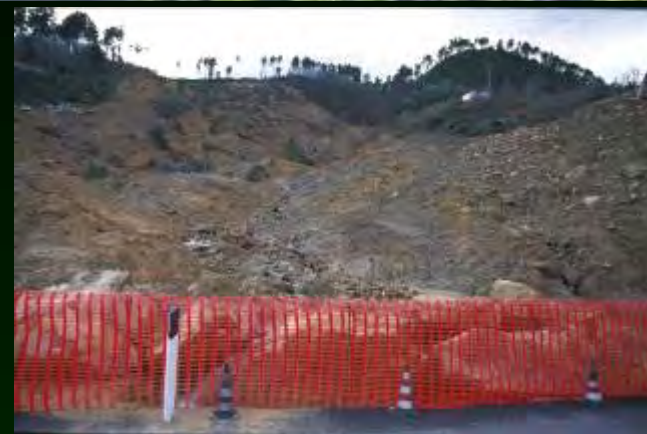
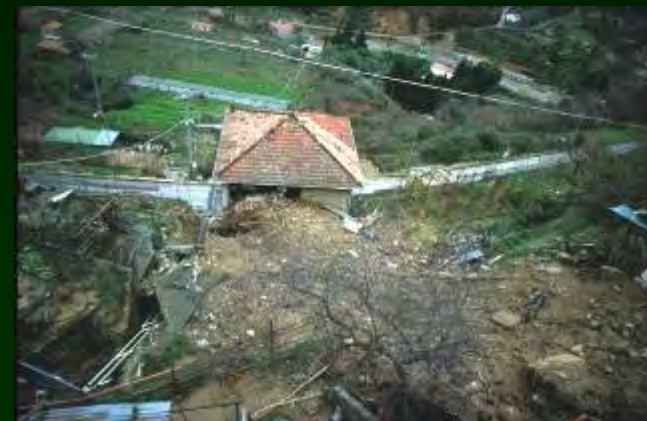
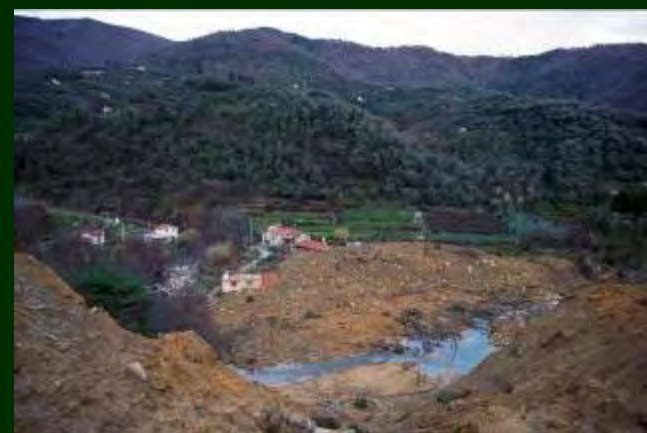
Ceriana (Imperia) landslides and severe flood (2000)

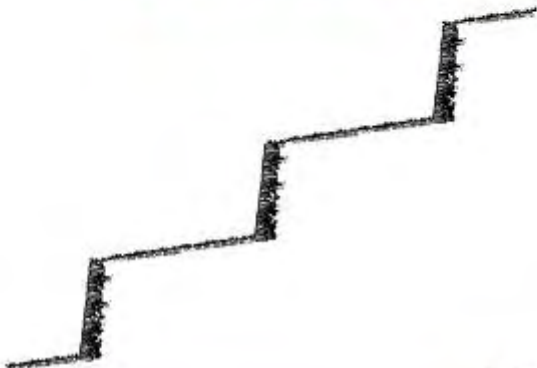
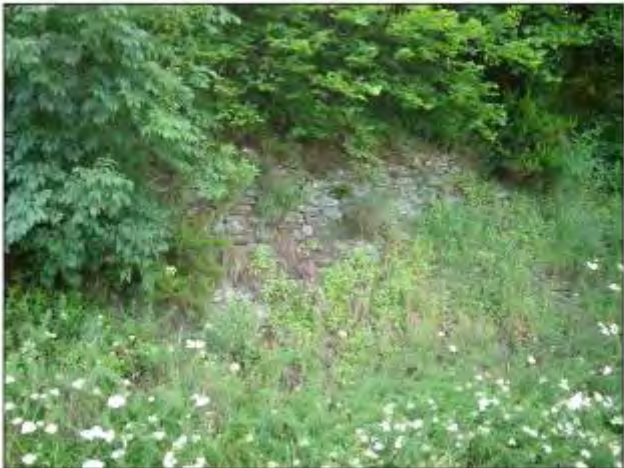
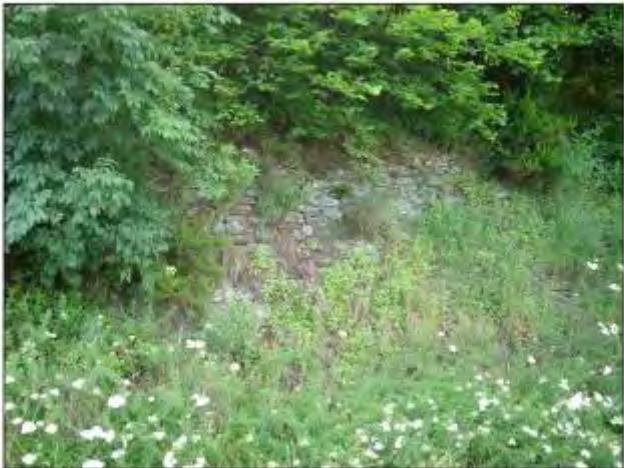
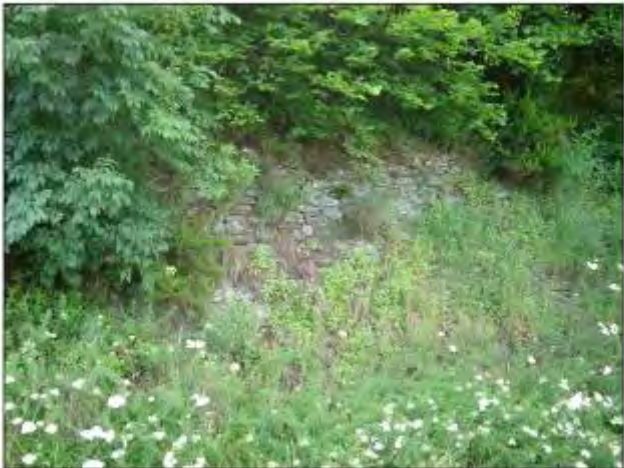
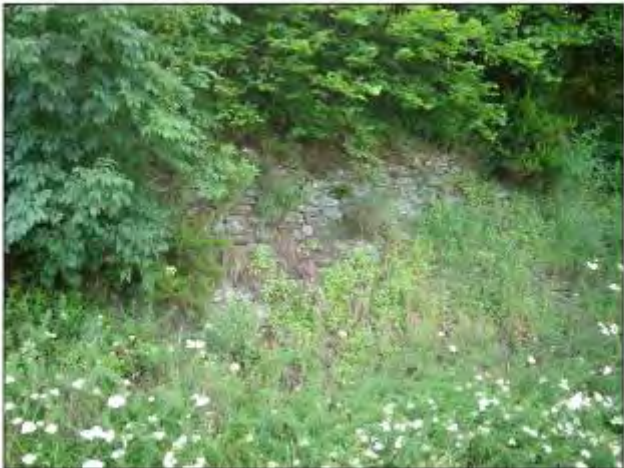
Terraces census *field detailed survey*

Bacino Rio Fontanelle		Area campione: Palazzo Scannabaggi		ZONA PROGETTO: A2	
Sottoarea terrazzata n° 12

CARATTERISTICHE DIMENSIONALI GENERALI					
Superficie area terrazzata (mq): 1661					
N° di fasce successive: 3					
STRUTTURA TERRAZZI

Tipologia: muratura a secco					
H media muri: 3.00 m					
Larghezza media lenza: 5.00 m					
Pendenza media muri: vedi sez.					
Pendenza media lenza: vedi sez.					
Paramenti murari: pietre di media pezzatura

Litologia pietre: Vedi-Inquadrimento geomorfologico					
Collegamenti verticali: sentiero ortogonale alle fasce					
Presenza manufatti/ripari: nessuno					
Accessibilità: scarsa					
Stato conservazione terrazzi: scarso					
note: n/a		Sezione scala 1:200			
COLTURE

Coltura prevalente: incolto					
Tecnica culturale: n/a					
Tipo di suolo: vedi -Inquadrimento geomorfologico					
Stato di conservazione delle colture: n/a

Sistema di regimazione idrica: n/a					
Verso di pendenza della lenza: verso valle					
Stato di conservazione della regimazione idrica: n/a					
Note:					
Aree di particolare valore paesistico - segnico: no					
Aree di particolare valore storico - culturale: no

RISCHIO IDROGEOLOGICO:					
R.I. = R2					
REGIME NORMATIVO VIGENTE:					
Em-ma

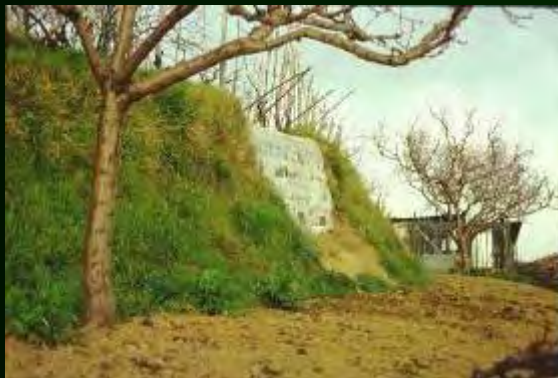
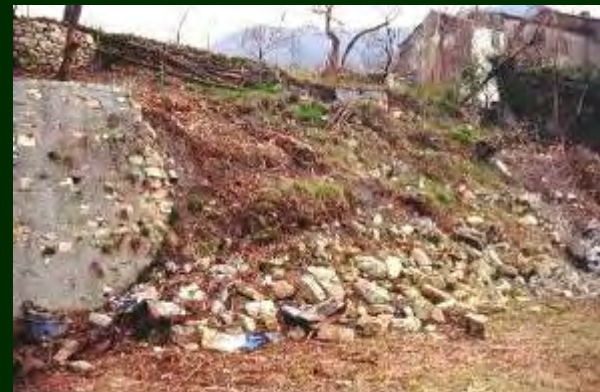
Integration of surveyed data and morphometry data

Dynamic model of geomorphic hazard

The model will allow to individuate the areas where the recovery is indispensable

The approach is based on the evidences given by field survey data; these data are analysed with the MS technique and the results will be used to build an hazard assessment model based on the decision tree technique (Murthy et al., 1994; Rossiter, 1990)
