# Terrasses et risques dans la haute vallée de la Roya

J.-M. Castex et A. Dagorne, géographes  
avec la collaboration SIG de M. Ben Jeddou  
et G. Davtian (Nice - ADI)

# Les espaces de terrasses dans la haute vallée de la Roya (Hameau de Granile, Alpes-Maritimes, France)

## Terraces of Granile (Tende, 06-F)

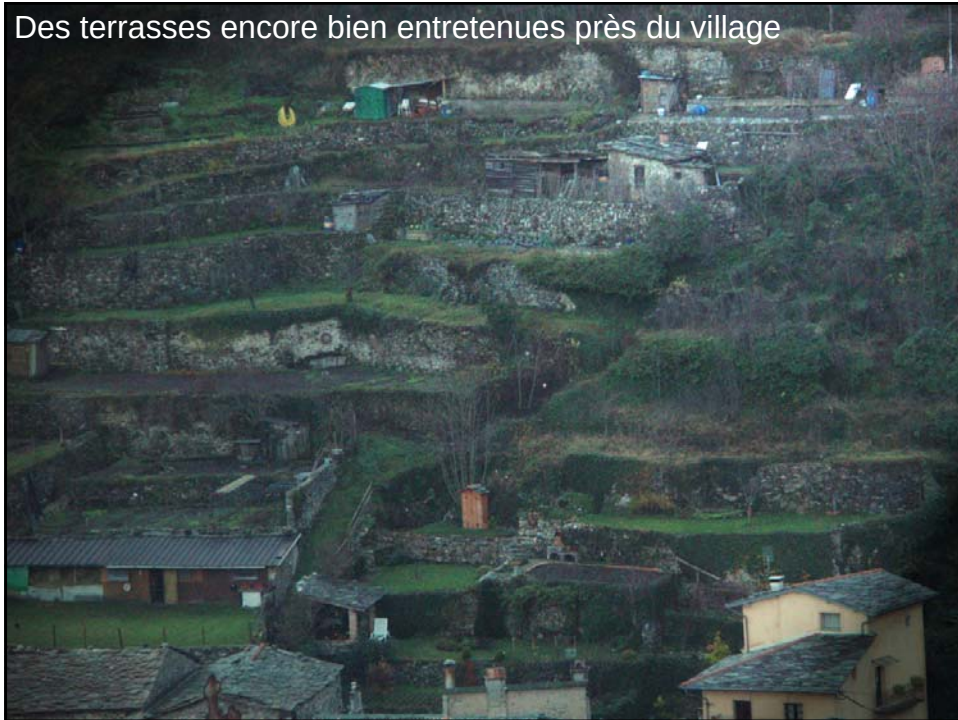
Un espace où les pentes ont souvent été aménagées en terrasses

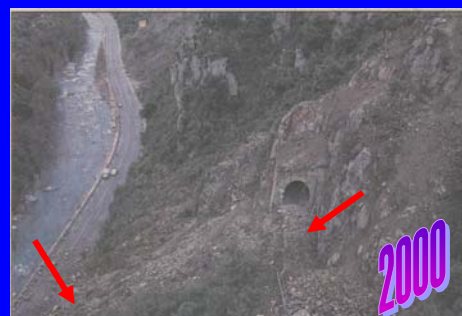
Document Nice-Matin

Les éboulements perturbent les réseaux de transports : route et voie ferrée.

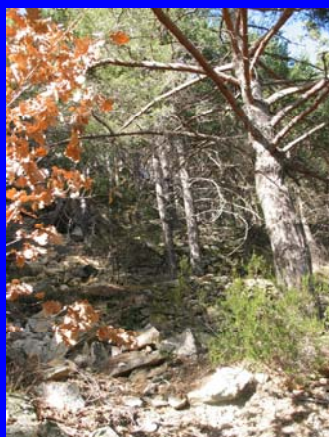
An astonishing good state of conservation

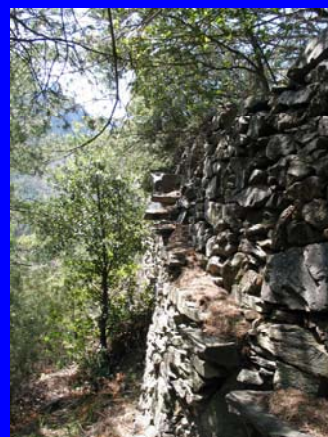
Pines are invading the abandoned terraces

In the ancient vineyard the walls are still undamaged

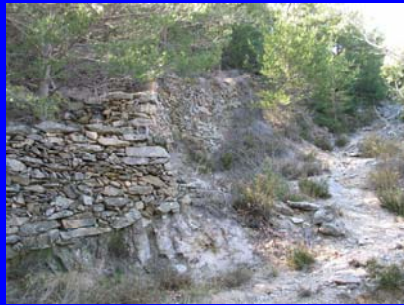
But erosion is menacing

Linear erosion along a path  
in sandy soils.

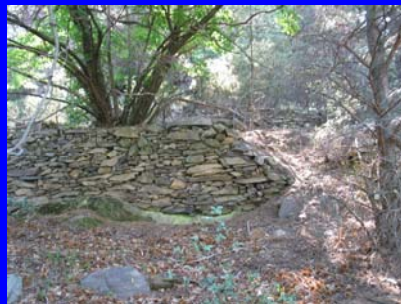
Breaks in terraces  
with sandy soils

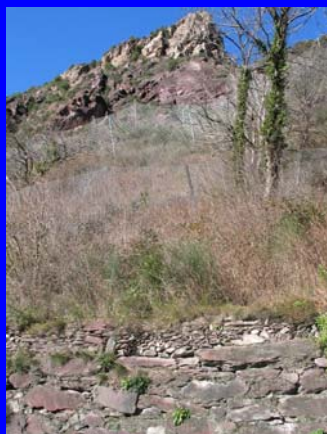
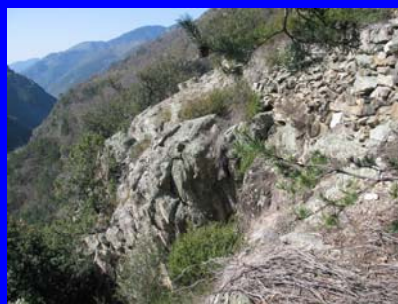
Actual works of protection  
against the stone falls: steel nets  
and dry stone walls

The last walls of terraces above the road.

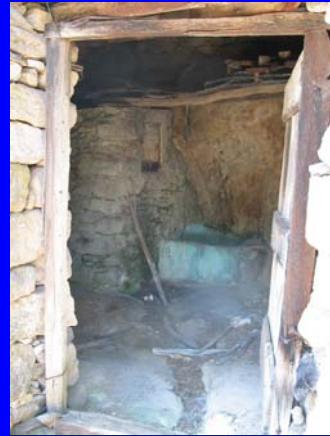
A traditional equipment for the wine production.

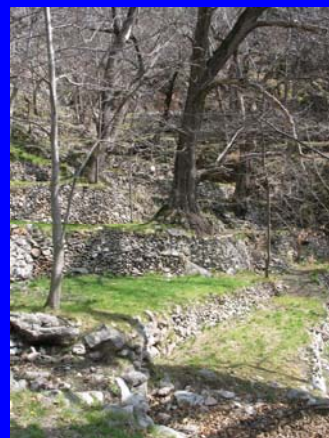
The walls remain in good condition in spite of the deep slopes in a well kept up chestnut grove.

The grass protects the stripes irrigated under the chestnuts.

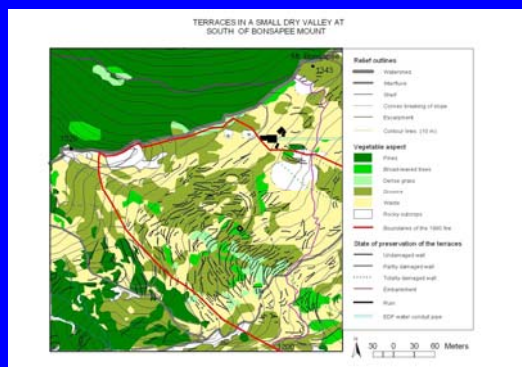
In this small dry valley the broad leaves and brooms are growing only on terraces after the 1990 fire.
